**Flood Control Project Maintenance
Levee Inspections**

Maintenance Issue Types Only, Levee Inspection Report By Mile - Spring 2019

Reclamation District No. 2062 Stewart

Waterway	Bank	Unit Miles	Inspection Start/End	Inspector
Unit No. 01 San Joaquin River	Left	2.64	05/21/2019 05/21/2019	Alberto De Leon

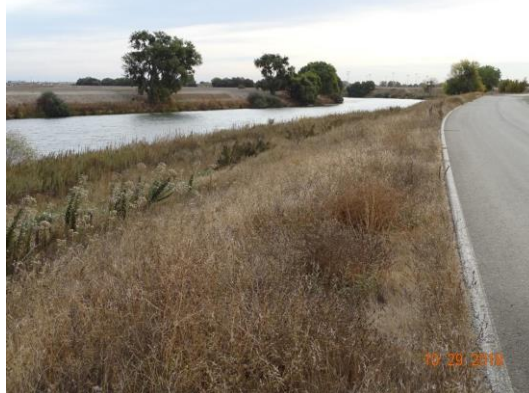
Photo 1 of 2 : SP_2019_RD2062_309_6_20190313_00001.jpg

LM Start	0.00	Rating **	M	Issue No.	6
LM End	2.63	Issue Type +	Ma	Location *	WS
Category	Earthen Levee			GPS Latitude/Longitude	
				Start	End
Item	Vegetation			37.807505 °	37.787249 °
				-121.328103 °	-121.308947 °
DWR ID	DWR_RD2062_01_f_2018_6				
Comment Code					
V1 : Control annual grass and weeds on the levee slopes and easements.					
Inspector Comment

Typical view of levee slopes.

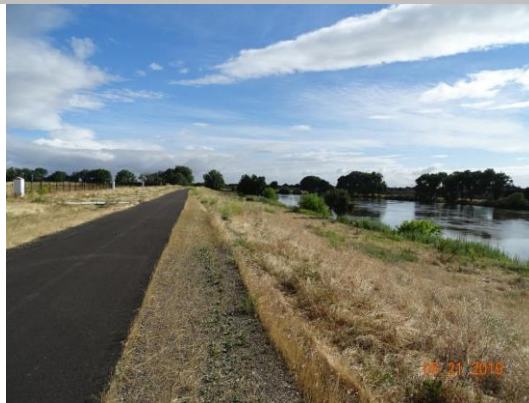
Photo 2 of 2 : SP_2019_RD2062_309_6_20190521_00011.jpg

Typical view of vegetation on waterside slope. (Spring 2019)

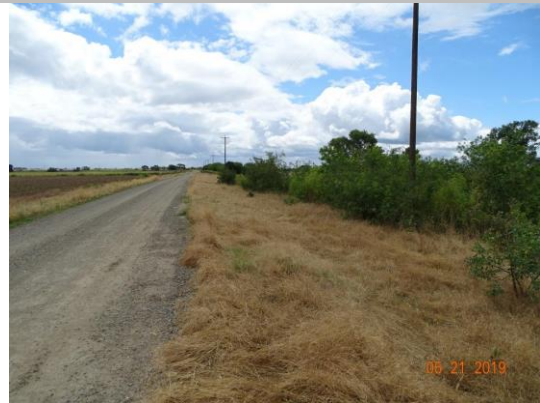
Photo 1 of 1 : SP_2019_RD2062_310_11_20190521_00037.jpg

Typical view of vegetation on waterside slope. (Spring 2019)

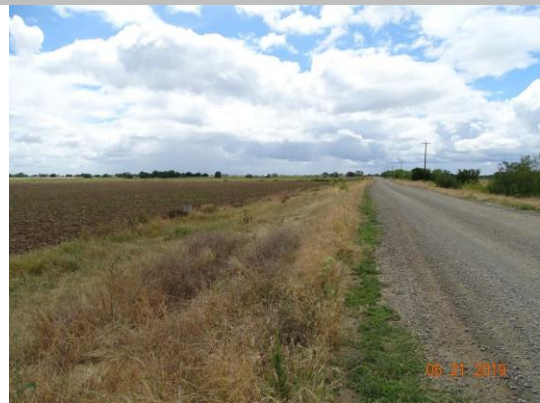
Photo 1 of 1 : SP_2019_RD2062_310_10_20190521_00038.jpg

LM Start	0.03	Rating **	M	Issue No.	10
LM End	3.93	Issue Type +	Ma	Location *	LS
Category	Earthen Levee			GPS Latitude/Longitude	
				Start	End
Item	Vegetation			37.778189 °	37.808790 °
				-121.333377 °	-121.390462 °
DWR ID	DWR_RD2062_02_s_2019_10				
Comment Code					
V1 : Control annual grass and weeds on the levee slopes and easements.					
Inspector Comment					
Annual vegetation is scheduled to be mowed in the month of June.

Typical view of vegetation on landside slope. (Spring 2019)

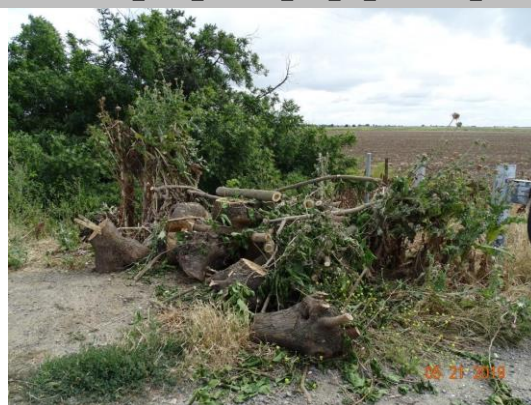
Photo 1 of 1 : SP_2019_RD2062_310_22_20190521_00036.jpg

View of pruning pile on landside slope. (Spring 2019)

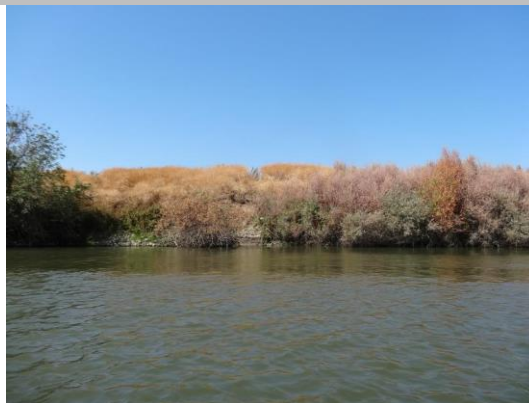
Photo 4 of 4 : SP_2019_RD2062_311_1_20190313_00004.jpg

LM Start	-0.03	Rating **	M	Issue No.	1 (cont)	
LM End	0.07	Issue Type +	Ma	Location *	WS	
Category	Supplemental			GPS Latitude/Longitude		
				Start		End
Item	DWR Erosion Survey			37.809514 °		37.809514 °
				-121.390125 °		-121.390125 °
DWR ID	RD2062U03RM29.94					
Comment Code						
Inspector Comment						
09/13/2017: The erosion site has expanded significantly along the river bank.						
11/09/2016: No significant change observed.						
06/25/2015: The erosion is below a large oak tree. Vegetation is visible around the erosion site. [2017 Site ID:RD2062U03RM29.94]

Close view of the erosion.

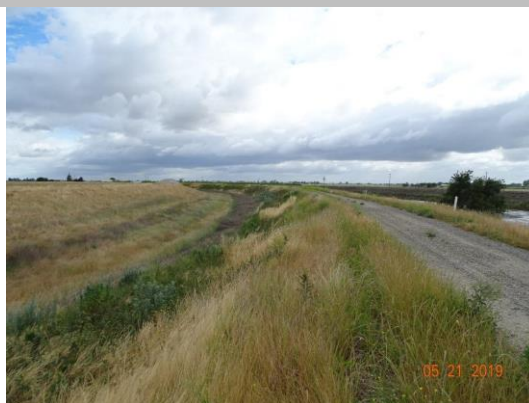
Photo 1 of 1 : SP_2019_RD2062_311_23_20190521_00057.jpg

LM Start	0.01	Rating **	M	Issue No.	23
LM End	4.62	Issue Type +	Ma	Location *	LS
Category	Earthen Levee			GPS Latitude/Longitude	
				Start	End
Item	Vegetation			37.809382 °	37.815697 °
				-121.390258 °	-121.334542 °
DWR ID	DWR_RD2062_03_s_2019_23				
Comment Code					
V2 : Remove the wild growth other than native grasses from the levee slopes.					
Inspector Comment					
Annual vegetation is scheduled to be mowed in June 2019.

Typical view of vegetation on landside slope. (Spring 2019)

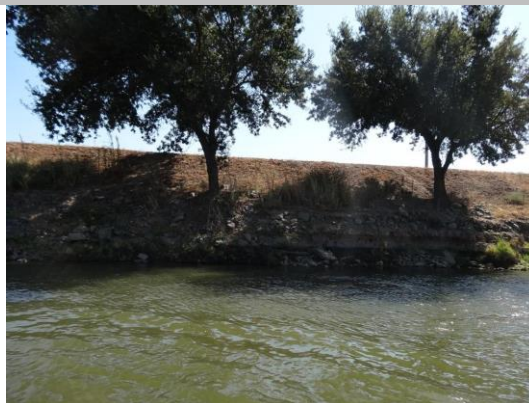
Photo 1 of 4 : SP_2019_RD2062_311_2_20190313_00005.jpg

Comment Code					
Inspector Comment					
09/13/2017: The erosion site has expanded significantly with the erosion length increased to approximately 90 ft from 40 ft. Signs of animal activities have been found at the site.					
07/25/2016: No significant change observed.					
06/25/2015: No significant change observed.					
07/02/2014: No significant change observed.					
08/13/2013: No significant change observed.					
08/07/2012: The site has been visited by boat survey. No significant change observed					
08/23/2011: Hard to view the erosion because of the dense vegetation and trees on site. The site is under the bush, close to the tree. [2017 Site ID:RD2062U03RM30.02]

Front view of the site.

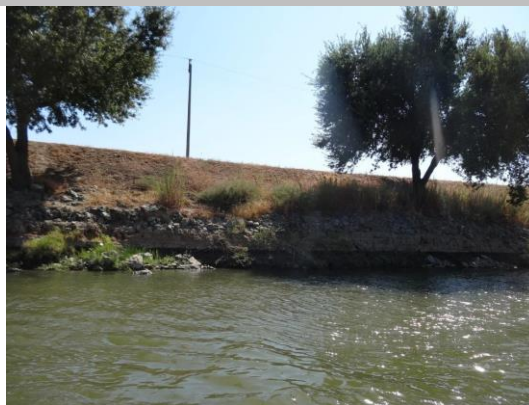
Photo 2 of 4 : SP_2019_RD2062_311_2_20190313_00006.jpg

Close view of the erosion. Note signs of animal activities at the site.

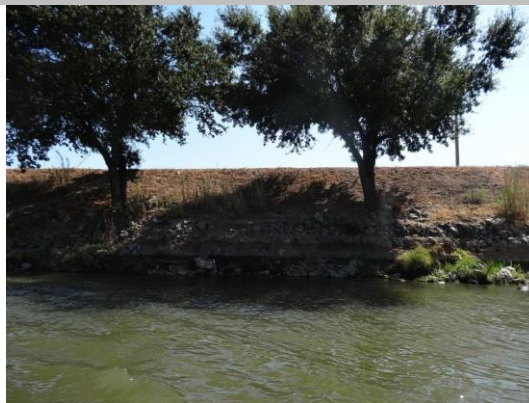
Photo 3 of 4 : SP_2019_RD2062_311_2_20190313_00007.jpg

Comment Code						
Inspector Comment						
09/13/2017: The erosion site has expanded significantly with the erosion length increased to approximately 90 ft from 40 ft. Signs of animal activities have been found at the site.						
07/25/2016: No significant change observed.						
06/25/2015: No significant change observed.						
07/02/2014: No significant change observed.						
08/13/2013: No significant change observed.						
08/07/2012: The site has been visited by boat survey. No significant change observed						
08/23/2011: Hard to view the erosion because of the dense vegetation and trees on site. The site is under the bush, close to the tree. [2017 Site ID:RD2062U03RM30.02]

Close view of the erosion.

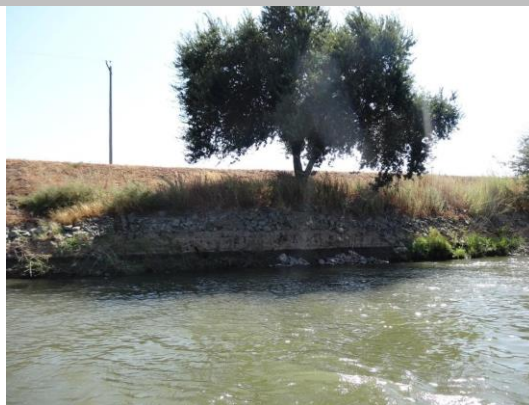
Photo 4 of 4 : SP_2019_RD2062_311_2_20190313_00008.jpg

Close view of the erosion.

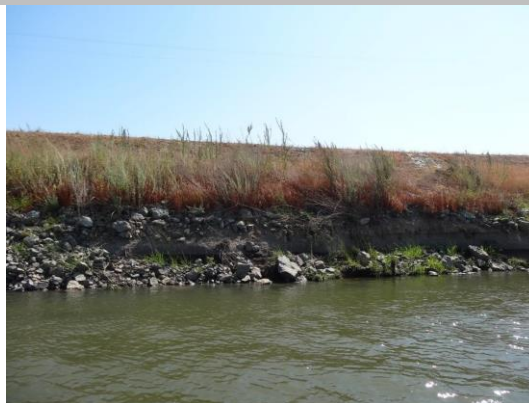
Photo 1 of 3 : SP_2019_RD2062_311_3_20190313_00009.jpg

LM Start	0.17	Rating **	M	Issue No.	3
LM End	0.17	Issue Type +	Ma	Location *	WS
Category	Supplemental			GPS Latitude/Longitude	
				Start	End
Item	DWR Erosion Survey			37.810268 °	37.810268 °
				-121.387495 °	-121.387495 °
DWR ID	DWR_RD2062_03_s_2018_3				
Comment Code					
Inspector Comment					
09/13/2017: No significant change observed.					
07/25/2016: No significant change observed.					
06/25/2015: No significant change observed.					
07/02/2014: No significant change observed.					
08/13/2013: No significant change observed.					
08/07/2012: The site has been visited by boat survey. No significant change observed					
08/23/2011: The protection at the levee toe has been washed away.					
[2017 Site ID:RD2062U03RM30.1]

Direct view of the site.

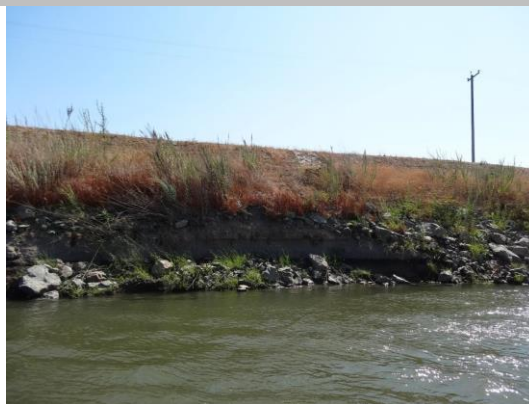
Photo 2 of 3 : SP_2019_RD2062_311_3_20190313_00010.jpg

Close view of the erosion.

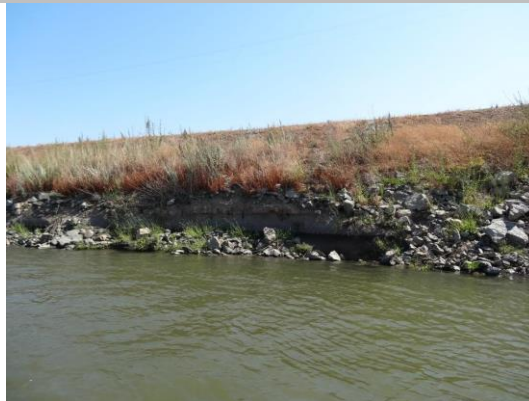
Photo 3 of 3 : SP_2019_RD2062_311_3_20190313_00011.jpg

LM Start	0.17	Rating **	M	Issue No.	3 (cont)	
LM End	0.17	Issue Type +	Ma	Location *	WS	
Category	Supplemental			GPS Latitude/Longitude		
				Start		End
Item	DWR Erosion Survey			37.810268 °		37.810268 °
				-121.387495 °		-121.387495 °
DWR ID	DWR_RD2062_03_s_2018_3					
Comment Code						
Inspector Comment						
09/13/2017: No significant change observed.						
07/25/2016: No significant change observed.						
06/25/2015: No significant change observed.						
07/02/2014: No significant change observed.						
08/13/2013: No significant change observed.						
08/07/2012: The site has been visited by boat survey. No significant change observed						
08/23/2011: The protection at the levee toe has been washed away.						
[2017 Site ID:RD2062U03RM30.1]

Close view of the erosion.

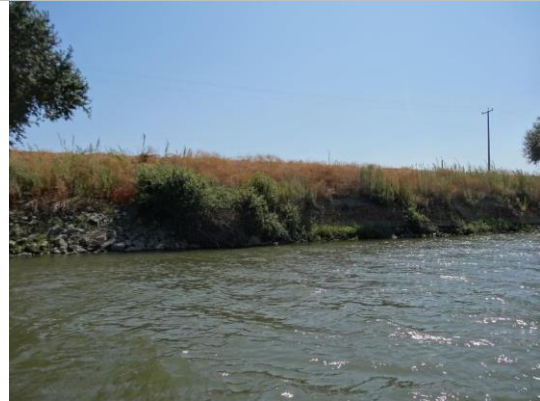
Photo 1 of 4 : SP_2019_RD2062_311_4_20190313_00012.jpg

09/13/2017: The erosion has developed vertically. More vegetation at the site.
 07/25/2106: No significant change observed. More vegetation observed at the site.
 06/25/2015: No significant change observed.
 07/02/2014: No significant change observed.
 08/13/2013: A new pocket erosion at the upper levee slope has been found directly above a large tree. The erosion might have been caused by internal pipe leakage or surface runoff.
 08/07/2012: The site has been visited by boat survey. No significant change observed
 08/23/2011: No significant change observed on site. Dense vegetation is visible along the water line.
 09/07/2010: No significant change observed on site. Much of the upper slope was recently cleared of vegetation by spraying. 4- to 6-foot vertical scarp and pocket erosions are lined along a span of 475 feet. In some sections, the vertical scarp encroaches into the levee prism. There is a lack of berm along this reach, exposing the levee slope to high flow velocities during normal and flood events.

08/06/2010: Recommended as local maintenance issue, per CLRO.
 03/09/2010: As discussed with Michael Moncrief of MBK Engineers, the site will be 'addressed' later this year.
 09/29/2009: No major change observed since last visit; pocket erosion and a vertical scarp forming; this site was combined with Site RM30.13 and 30.02 with a combined total erosion length of 475 feet; recommended as annual assessment and monitoring of the site, per CLRO CES Evaluation 2008 Report; previously rated "M".
 11/05/2008: Top of vertical scarp has rip rap that appears to be sliding; rodent holes; existing toe rip rap. [2017 Site ID:RD2062U03RM30.19]

View of the pocket erosion.

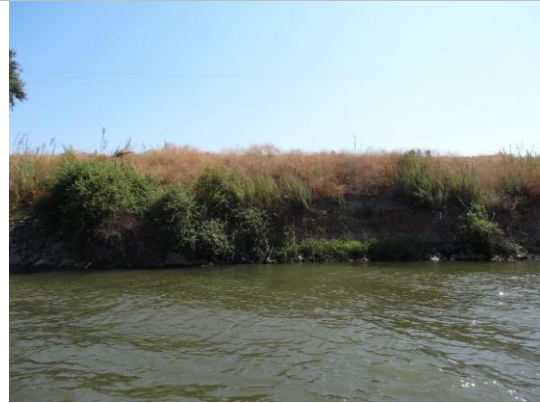
Photo 2 of 4 : SP_2019_RD2062_311_4_20190313_00013.jpg

Comment Code						
Inspector Comment						
09/13/2017: The erosion has developed vertically. More vegetaiaon at the site.						
07/25/2106: No significant change observed. More vegetation observed at the site.						
06/25/2015: No significant change observed.						
07/02/2014: No significant change observed.						
08/13/2013: A new pocket erosion at the upper levee slope has been found directly above a large tree. The erosion might have been caused by internal pipe leakage or surface runoff.						
08/07/2012: The site has been visited by boat survey. No significant change observed						
08/23/2011: No significant change observed on site. Dense vegetation is visible along the water line.						
09/07/2010: No significant change observed on site. Much of the upper slope was recently cleared of vegetation by spraying. 4- to 6-foot vertical scarp and pocket erosions are lined along a span of 475 feet. In some sections, the vertical scarp encroaches into the levee prism. There is a lack of berm along this reach, exposing the levee slope to high flow velocities during normal and flood events.

08/06/2010: Recommended as local maintenance issue, per CLRO.						
03/09/2010: As discussed with Michael Moncrief of MBK Engineers, the site will be 'addressed' later this year.						
09/29/2009: No major change observed since last visit; pocket erosion and a vertical scarp forming; this site was combined with Site RM30.13 and 30.02 with a combined total erosion length of 475 feet; recommended as annual assessment and monitoring of the site, per CLRO CES Evaluation 2008 Report; previously rated "M".						
11/05/2008: Top of vertical scarp has rip rap that appears to be sliding; rodent holes; existing toe rip rap. [2017 Site ID:RD2062U03RM30.19]

Close view of the pocket erosion. Note the dense vegetation at the site.

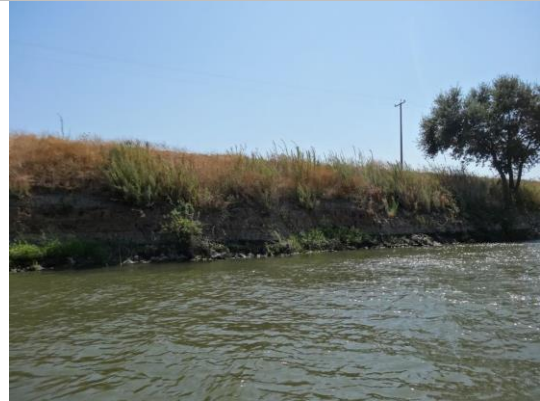
Photo 3 of 4 : SP_2019_RD2062_311_4_20190313_00014.jpg

09/13/2017: The erosion has developed vertically. More vegetation at the site.
 07/25/2016: No significant change observed. More vegetation observed at the site.
 06/25/2015: No significant change observed.
 07/02/2014: No significant change observed.
 08/13/2013: A new pocket erosion at the upper levee slope has been found directly above a large tree. The erosion might have been caused by internal pipe leakage or surface runoff.
 08/07/2012: The site has been visited by boat survey. No significant change observed
 08/23/2011: No significant change observed on site. Dense vegetation is visible along the water line.
 09/07/2010: No significant change observed on site. Much of the upper slope was recently cleared of vegetation by spraying. 4- to 6-foot vertical scarp and pocket erosions are lined along a span of 475 feet. In some sections, the vertical scarp encroaches into the levee prism. There is a lack of berm along this reach, exposing the levee slope to high flow velocities during normal and flood events.

08/06/2010: Recommended as local maintenance issue, per CLRO.
 03/09/2010: As discussed with Michael Moncrief of MBK Engineers, the site will be 'addressed' later this year.
 09/29/2009: No major change observed since last visit; pocket erosion and a vertical scarp forming; this site was combined with Site RM30.13 and 30.02 with a combined total erosion length of 475 feet; recommended as annual assessment and monitoring of the site, per CLRO CES Evaluation 2008 Report; previously rated "M".
 11/05/2008: Top of vertical scarp has rip rap that appears to be sliding; rodent holes; existing toe rip rap. [2017 Site ID:RD2062U03RM30.19]

Front view of the site with dense vegetation.

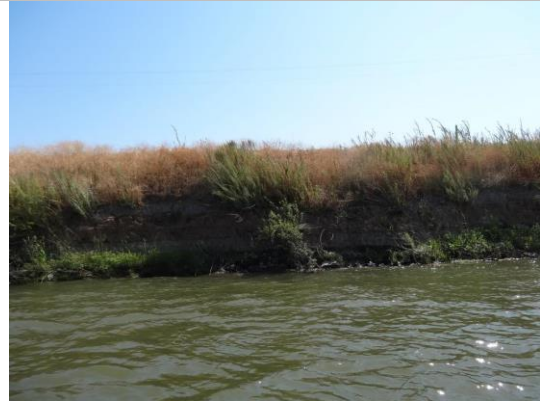
Photo 4 of 4 : SP_2019_RD2062_311_4_20190313_00015.jpg

Comment Code						
Inspector Comment						
09/13/2017: The erosion has developed vertically. More vegetaion at the site.						
07/25/2106: No significant change observed. More vegetation observed at the site.						
06/25/2015: No significant change observed.						
07/02/2014: No significant change observed.						
08/13/2013: A new pocket erosion at the upper levee slope has been found directly above a large tree. The erosion might have been caused by internal pipe leakage or surface runoff.						
08/07/2012: The site has been visited by boat survey. No significant change observed						
08/23/2011: No significant change observed on site. Dense vegetation is visible along the water line.						
09/07/2010: No significant change observed on site. Much of the upper slope was recently cleared of vegetation by spraying. 4- to 6-foot vertical scarp and pocket erosions are lined along a span of 475 feet. In some sections, the vertical scarp encroaches into the levee prism. There is a lack of berm along this reach, exposing the levee slope to high flow velocities during normal and flood events.

08/06/2010: Recommended as local maintenance issue, per CLRO.						
03/09/2010: As discussed with Michael Moncrief of MBK Engineers, the site will be 'addressed' later this year.						
09/29/2009: No major change observed since last visit; pocket erosion and a vertical scarp forming; this site was combined with Site RM30.13 and 30.02 with a combined total erosion length of 475 feet; recommended as annual assessment and monitoring of the site, per CLRO CES Evaluation 2008 Report; previously rated "M".						
11/05/2008: Top of vertical scarp has rip rap that appears to be sliding; rodent holes; existing toe rip rap. [2017 Site ID:RD2062U03RM30.19]

Front view of the site. The erosion has developed along the levee slope.

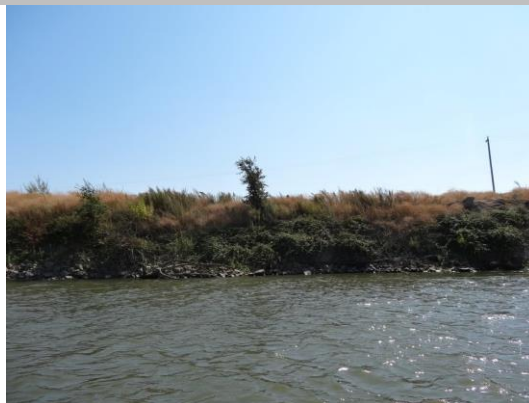
Photo 1 of 3 : SP_2019_RD2062_311_5_20190313_00016.jpg

LM Start	0.35	Rating **	M	Issue No.	5
LM End	0.35	Issue Type +	Ma	Location *	WS
Category	Supplemental			GPS Latitude/Longitude	
				Start	End
Item	DWR Erosion Survey			37.811101 °	37.811101 °
				-121.384402 °	-121.384402 °
DWR ID	RD2062U03RM30.27				
Comment Code					
Inspector Comment					
09/13/2017: No significant change observed.					
07/25/2016: No significant change observed.					
06/25/2015: No significant change observed.					
07/02/2014: No significant change observed.					
08/13/2013: No significant change observed.					
08/07/2012: The site has been visited by boat survey. No significant change observed					
08/23/2011: The site is right at the downstream of a river bend. [2017 Site ID:RD2062U03RM30.27]

Front view of the erosion.

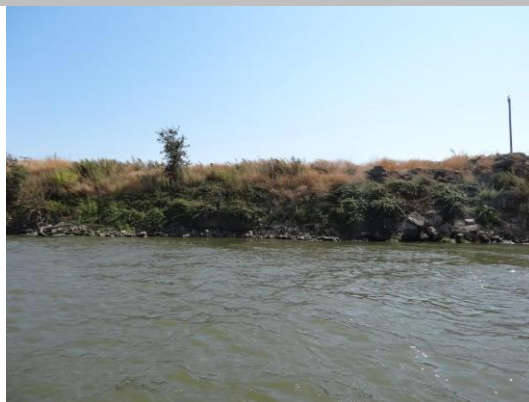
Photo 2 of 3 : SP_2019_RD2062_311_5_20190313_00017.jpg

Close view of the site. Note the dense vegetation at the site.

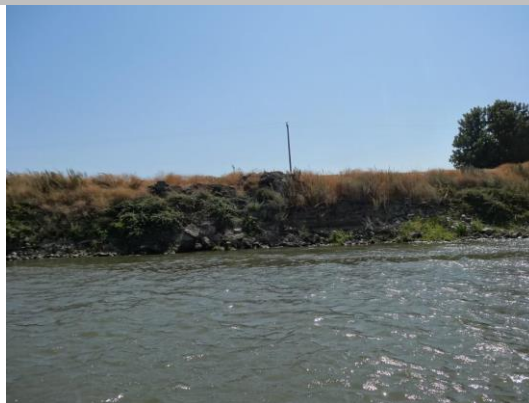
Photo 3 of 3 : SP_2019_RD2062_311_5_20190313_00018.jpg

LM Start	0.35	Rating **	M	Issue No.	5 (cont)	
LM End	0.35	Issue Type +	Ma	Location *	WS	
Category	Supplemental			GPS Latitude/Longitude		
				Start		End
Item	DWR Erosion Survey			37.811101 °		37.811101 °
				-121.384402 °		-121.384402 °
DWR ID	RD2062U03RM30.27					
Comment Code						
Inspector Comment						
09/13/2017: No significant change observed.						
07/25/2016: No significant change observed.						
06/25/2015: No significant change observed.						
07/02/2014: No significant change observed.						
08/13/2013: No significant change observed.						
08/07/2012: The site has been visited by boat survey. No significant change observed						
08/23/2011: The site is right at the downstream of a river bend. [2017 Site ID:RD2062U03RM30.27]

Front view of the erosion.

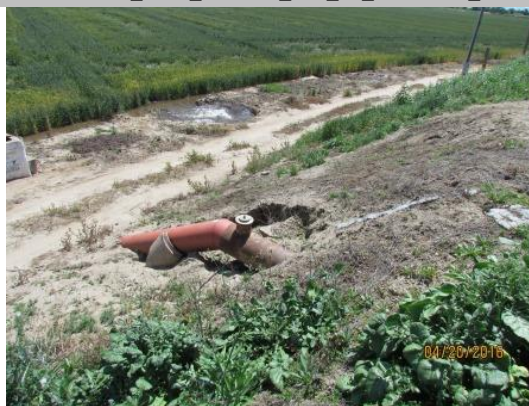
Photo 1 of 1 : SP_2019_RD2062_311_38_20190313_00041.jpg

LM Start	0.51	Rating **	M	Issue No.	38	
LM End	0.51	Issue Type +	Ma	Location *	LS	
Category	Earthen Levee			GPS Latitude/Longitude		
				Start		End
Item	Erosion / Bank Caving			37.812552 °		37.812552 °
				-121.382781 °		-121.382781 °
DWR ID	DWR_RD2062_03_s_2016_38					
Comment Code						
E2 : Schedule repair of erosion site prior to the next inspection.						
Inspector Comment

View of the landside levee slope erosion around the pipe.

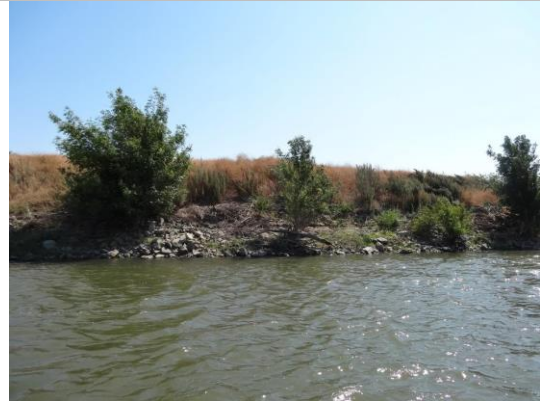
Photo 1 of 3 : SP_2019_RD2062_311_7_20190313_00019.jpg

09/13/2017: No significant change observed.
 07/25/2016: No significant change observed.
 06/25/2015: No significant change observed.
 07/02/2014: No significant change observed.
 08/13/2013: No significant change observed.
 08/07/2012: The site has been visited by boat survey. No significant change observed.
 08/23/2011: No significant change observed on site.
 09/07/2010: No significant change observed on site. Much of the placed rip rap revetment has slid. It is no longer adequately protecting the slope.
 08/06/2010: Recommended as local maintenance issue, per CLRO Report.
 03/09/2010: As discussed with Michael Moncrief of MBK, site will be 'addressed' this year.
 09/29/2009: No major change observed since last visit; a section of the rip rap has slipped, exposing a levee section that has eroded; recommended as local maintenance issue, per CLRO CES Evaluation 2008 Report; Site # is the same as RM30.43, LM0.63; previously rated "U".

Close view of the site.

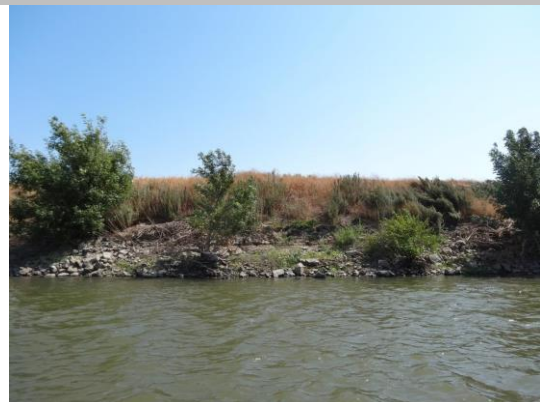
Photo 2 of 3 : SP_2019_RD2062_311_7_20190313_00020.jpg

Front view of the site.

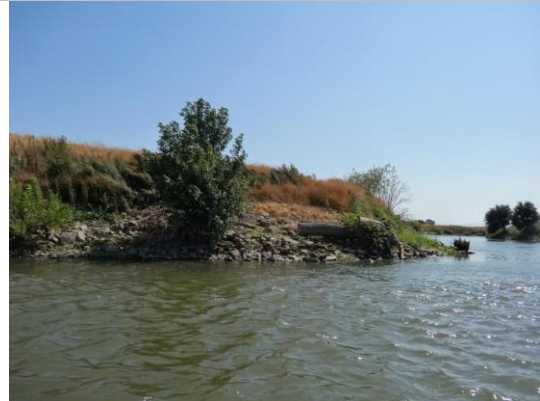
Photo 3 of 3 : SP_2019_RD2062_311_7_20190313_00021.jpg

Front view of the site.

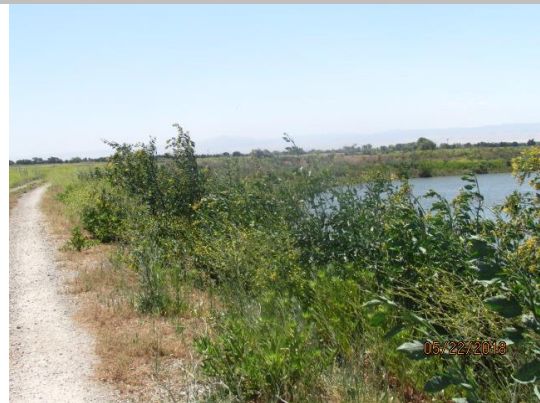
Photo 1 of 3 : SP_2019_RD2062_311_22_20190313_00035.jpg

LM Start	1.14	Rating **	U	Issue No.	22
LM End	1.36	Issue Type +	Ma	Location *	WS
Category	Earthen Levee			GPS Latitude/Longitude	
				Start	End
Item	Vegetation			37.819166 °	37.821072 °
				-121.379366 °	-121.377031 °
DWR ID	DWR_RD2062_03_s_2018_22				
Comment Code					
V2 : Remove the wild growth other than native grasses from the levee slopes.					
Inspector Comment

Looking southwest at dense vegetation (Tobacco plants) on waterward slope. (Spring 2018)

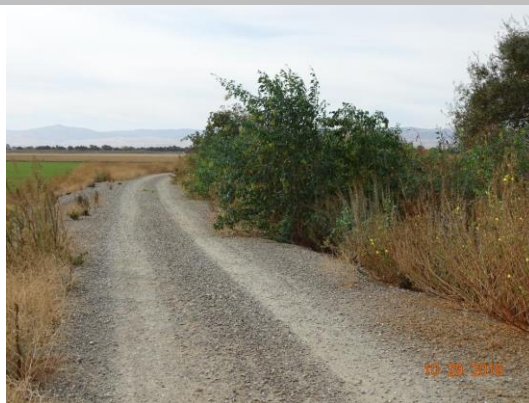
Photo 2 of 3 : SP_2019_RD2062_311_22_20190313_00036.jpg

Looking west at dense veg. on waterward slope. (Fall 2018)

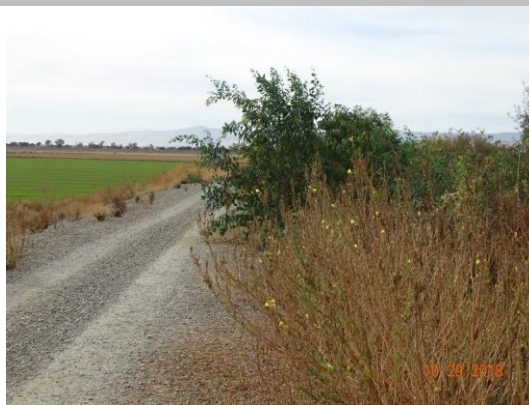
Photo 3 of 3 : SP_2019_RD2062_311_22_20190313_00037.jpg

Looking southwest at dense veg (Tabacco plant) on waterward slope. (Fall 2018)

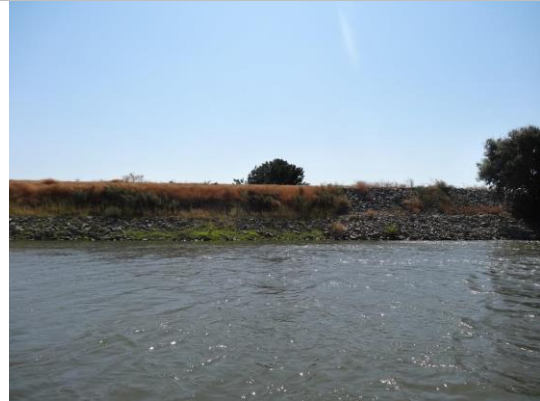
Photo 1 of 3 : SP_2019_RD2062_311_8_20190313_00022.jpg

Front view of the site.

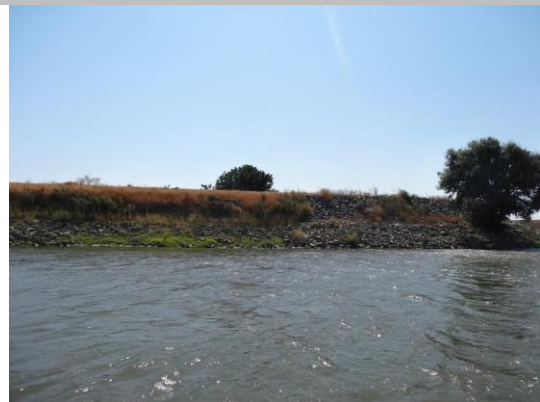
Photo 2 of 3 : SP_2019_RD2062_311_8_20190313_00023.jpg

Front view of the site.

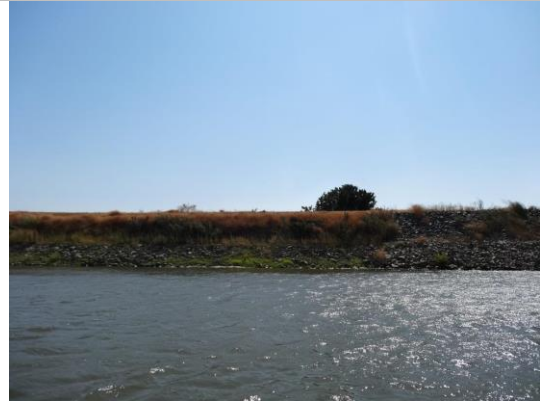
Photo 3 of 3 : SP_2019_RD2062_311_8_20190313_00024.jpg

Front view of the site.

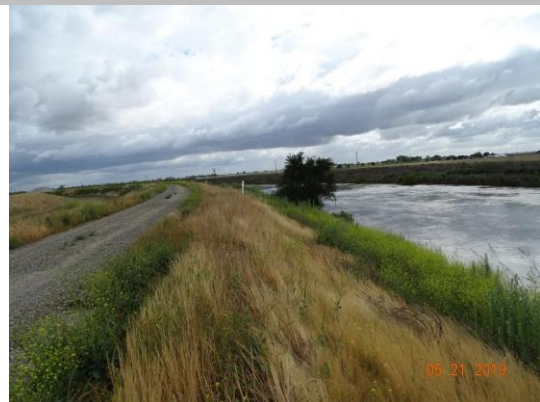
Photo 1 of 1 : SP_2019_RD2062_311_15_20190521_00058.jpg

LM Start	1.36	Rating **	M	Issue No.	15
LM End	5.53	Issue Type +	Ma	Location *	WS
Category	Earthen Levee			GPS Latitude/Longitude	
				Start	End
Item	Vegetation			37.821032 °	37.807536 °
				-121.377046 °	-121.328314 °
DWR ID	DWR_RD2062_03_s_2019_15				
Comment Code					
V2 : Remove the wild growth other than native grasses from the levee slopes.					
Inspector Comment					
Annual vegetation is scheduled to be mowed in June 2019.

Typical view of vegetation on waterside slope. (Spring 2019)

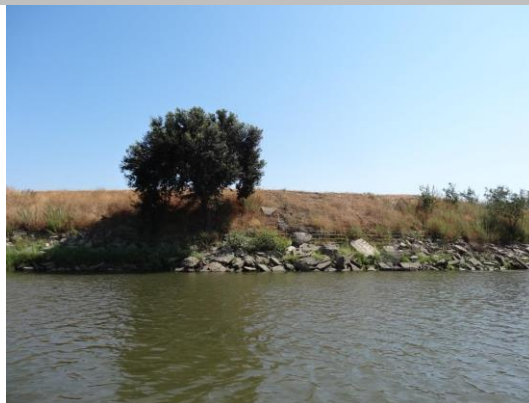
Photo 1 of 4 : SP_2019_RD2062_311_9_20190313_00025.jpg

Front view of the erosion site.

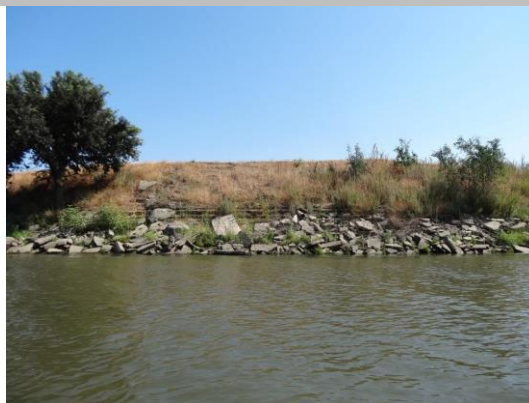
Photo 2 of 4 : SP_2019_RD2062_311_9_20190313_00026.jpg

Close view of the site.

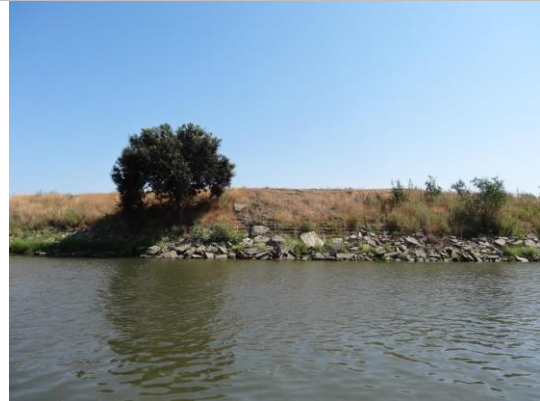
Photo 3 of 4 : SP_2019_RD2062_311_9_20190313_00027.jpg

Front view of the site. Note the existing broken concrete on levee slope and at the levee toe.

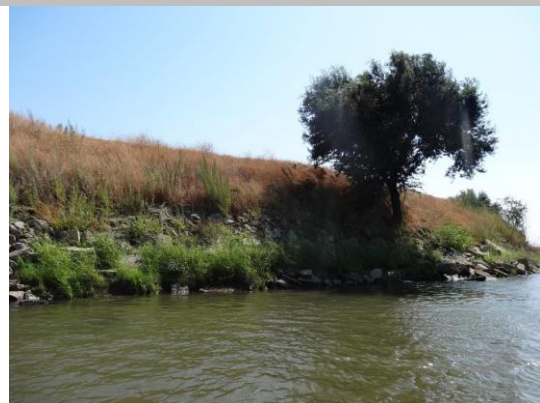
Photo 4 of 4 : SP_2019_RD2062_311_9_20190313_00028.jpg

Close view of the site.

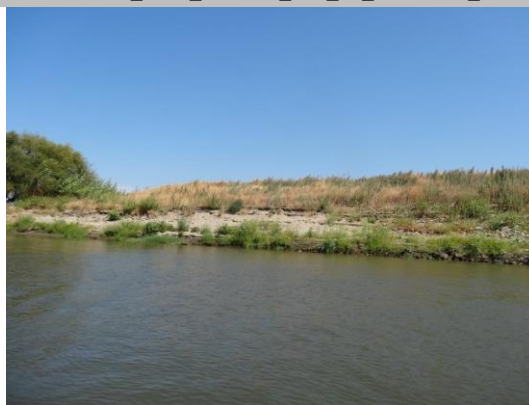
Photo 1 of 3 : SP_2019_RD2062_311_10_20190313_00029.jpg

Front view of the erosion located at the inside of a sharp river bend.

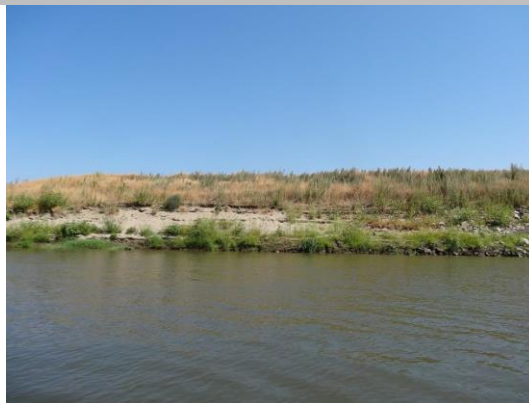
Photo 2 of 3 : SP_2019_RD2062_311_10_20190313_00030.jpg

Close view of the erosion.

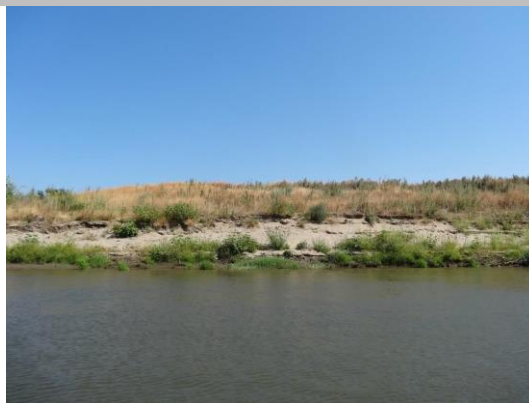
Photo 3 of 3 : SP_2019_RD2062_311_10_20190313_00031.jpg

Close view of the erosion. Note the sandy material of the river bank at the erosion site.
